TRANSPORTATION SAFETY  
BUREAU

**Subject: Final Report** on serious incident, **YR-ATG, 17 June 2011, BUD, Hungary**  
(file number: **2011-120-4P**)

**FINAL REPORT**  
**2011-120-4P**  
**SERIOUS INCIDENT**  
**BUDAPEST**  
**17 JUNE 2011**  
**ATR42-500**  
**YR-ATG**

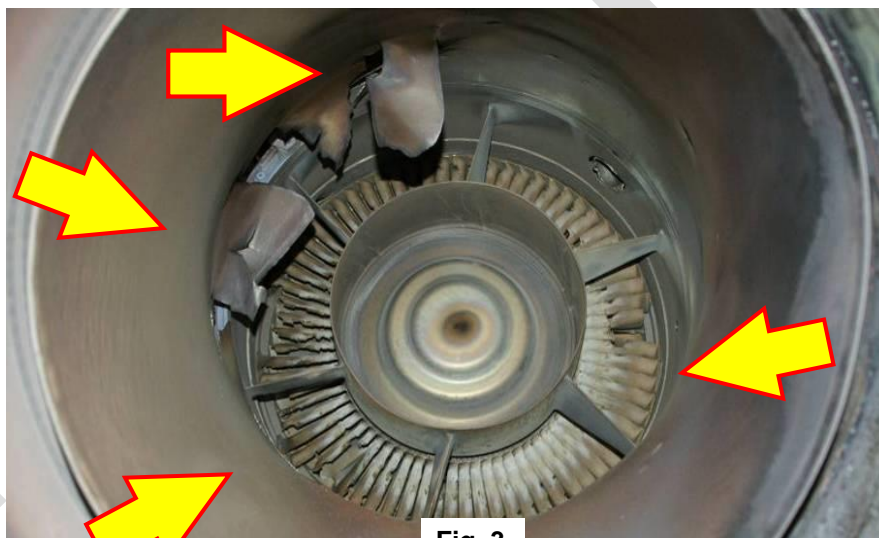
The Power Turbine of the RH engine (engine No.2) (Fig. 3), the exhaust pipe and the engine nacelle (Fig. 4) sustained heavy damage.

As a result of major failure of engine No.2 a fire developed in the engine nacelle. The fire protection system triggered a fire warning to which the flight crew responded and successfully put out the fire with the built-in fire extinguishing system. The fire caused considerable damage near the turbine section but was confined to the inside of the nacelle (see Fig. 3 and 4).

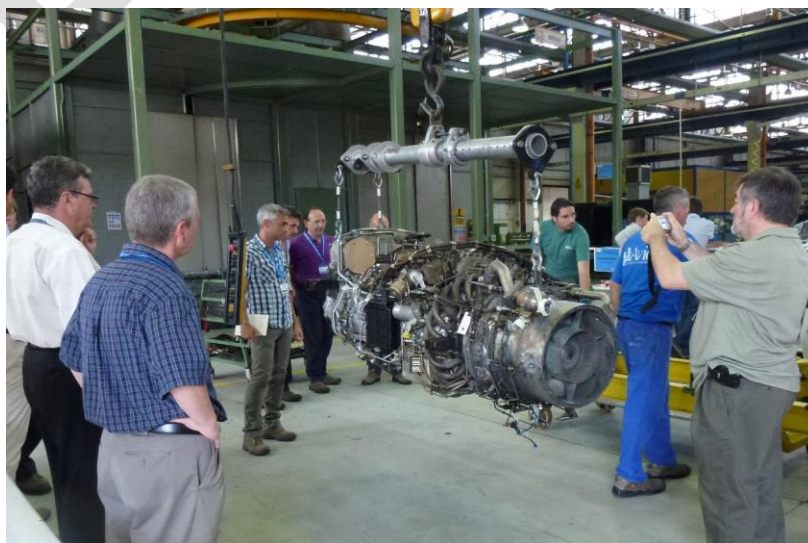
**Fig. 10: Engine inspection prior to disassembly at Avio, 13 July 2011**

- Fire damage on wiring and near turbine section (at a number of places).
- Mass fracture of Power Turbine 2nd stage (PT2) blades.
- Radially displaced oil pipes (supply, drain, ventilation) of bearings 6-7.
- Broken ventilation pipe of bearing 4.
- Oil level normal (1 mark below Full).
- Main and return line oil filters blocked (blockage indicators out).
- Dirty turbine chip indicator.
- Clean gearbox chip indicator.
- Chip on the low pressure rotor RPM sensor.
- Gas generator section rotors rotate freely.
- Power Turbine seized.

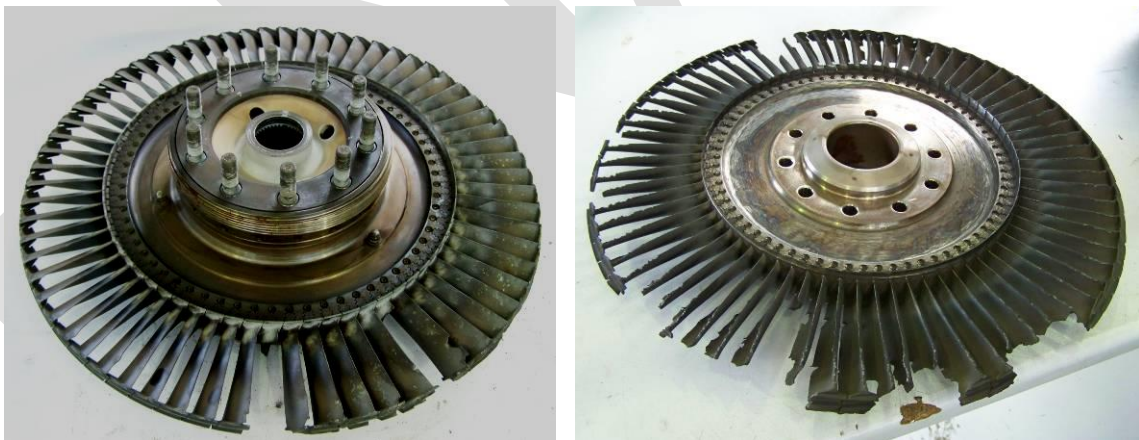
Fig. 11: Power Turbine Stage 1 and Stage 2 rotor disks

- **PT2 rotor** (Fig. 11, RH photo): Impact damage on all blades. Scratching marks on the frontal surface of the rotor.
- **PT2 stator**: Damaged leading edges on vanes. Heavy damage on the outer areas of Stage 2 near 10 and 4 o'clock as well as of Stage 1 near 4 o'clock.
- **PT1 rotor** (Fig. 11, LH photo): Two missing blades (No. 41 and 47).
- **Joining housing of bearings 6-7** (Part No.: 3111633-01): Damaged seal. The conical end part of radial oil pipes found in the bearing housing, broken.
- **Radial oil pipes of bearings 6-7** (3 pipes) (Part No.: 3111243-01): Broken (see above)

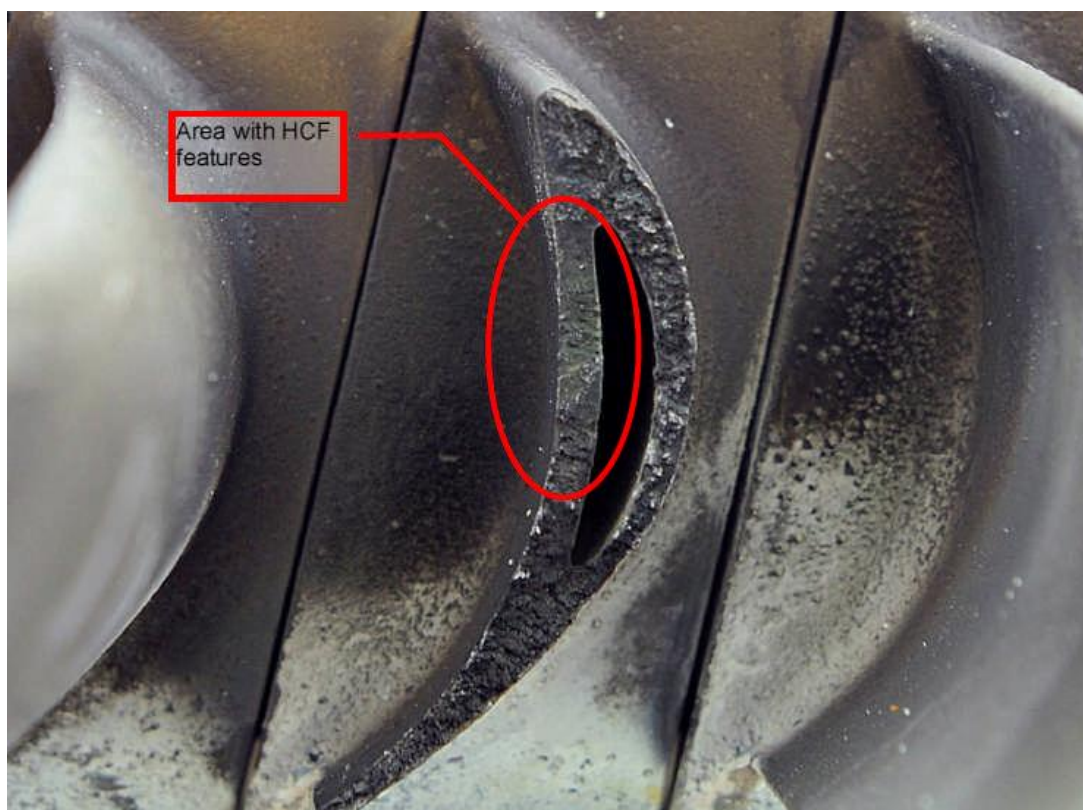
Fig. 12 (source: Pratt & Whitney Canada report No. 11GS00021)

A close-up photo (Fig. 12) shows the surface of the fracture. The High Cycle Fatigue (HCF) affected area is highlighted. (The rest of the damage was caused by tensile overload.)

2. On the concave surface of blade No.41, 0.32" above blade platform there is a material defect (size 0.062"x0.040"). A crack developed from here towards both leading and trailing edge of the blade. The blade fractured when the length of the crack reached 0.25". Since the broken blade is missing, it was impossible to determine whether the hidden material defect could have been revealed by X-ray inspection. The X-ray photos taken at the time of manufacturing of the blade were not available (they were discarded when their obligatory storage period expired).

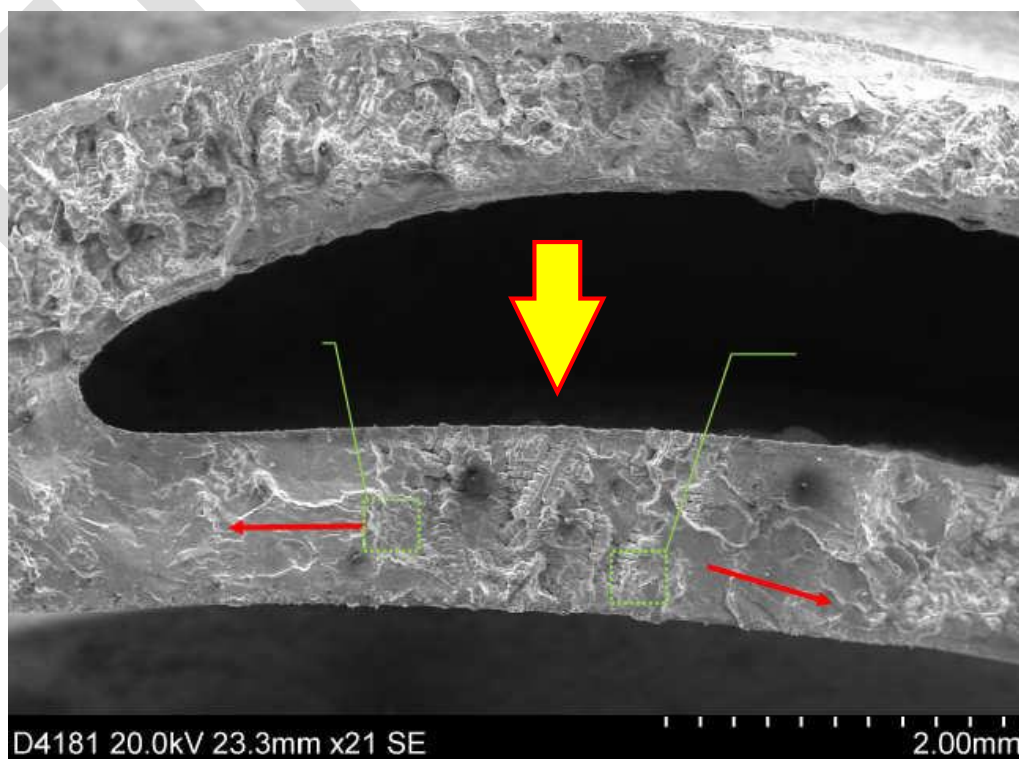
Fig. 13 (source: Pratt & Whitney Canada report No. 11GS00021)

A photo taken with a scanning electron microscope (SEM) shows a more detailed view of the HCF area (Fig. 13). The yellow arrow indicates the location of the material defect from where the fatigue crack started to develop while the narrow red arrows show the directions of the propagation of the crack.

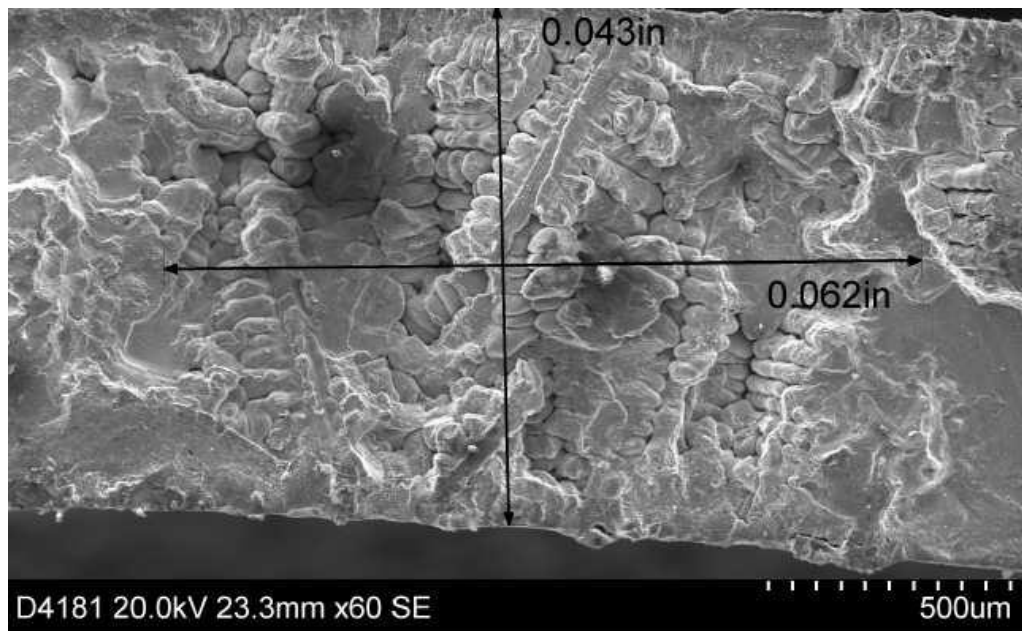
Fig. 14 (source: Pratt & Whitney Canada report No. 11GS00021)

A higher resolution SEM photo (Fig. 14) shows the details of the material defect (a microshrinkage porosity).

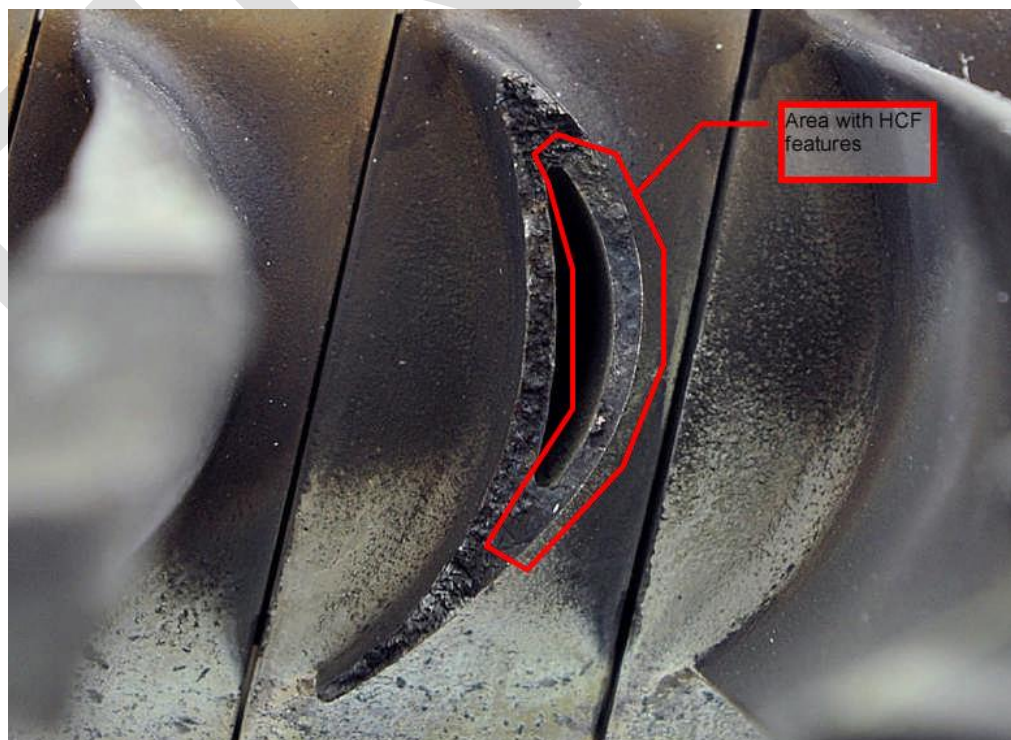
Fig. 15 (source: Pratt & Whitney Canada report No. 11GS00021)

A close-up photo (Fig. 15) shows the surface of the fracture. The High Cycle Fatigue affected area is highlighted. (The rest of the damage was caused by tensile overload.)

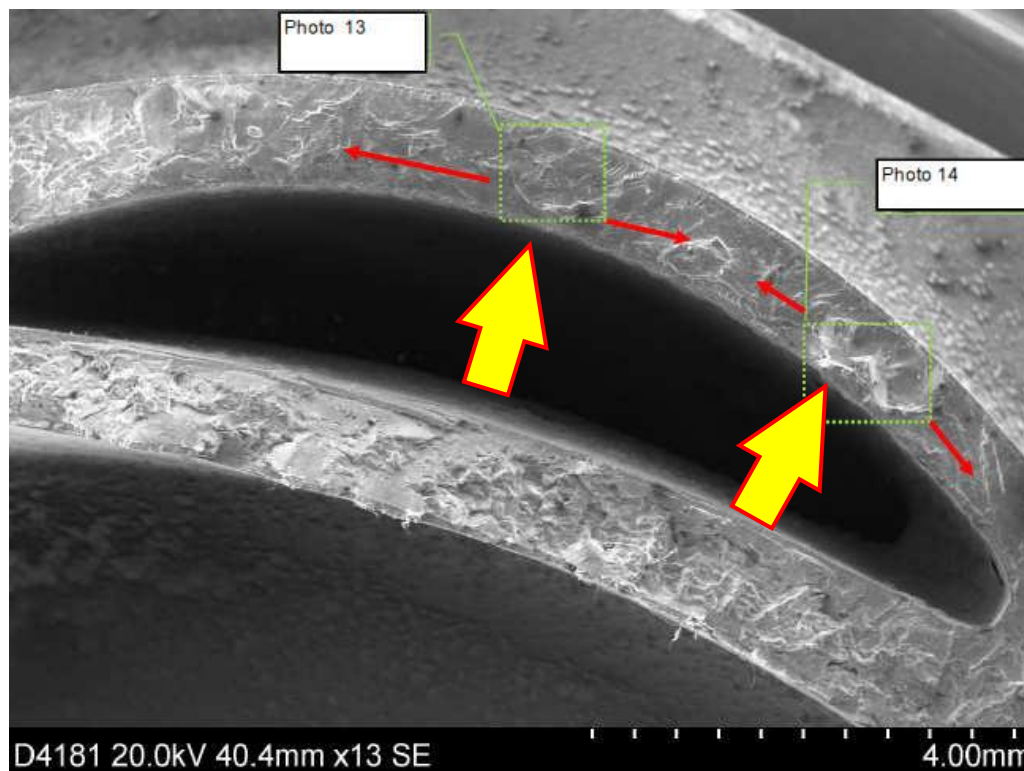
Fig. 16 (source: Pratt & Whitney Canada report No. 11GS00021)

Fig. 16 shows material defects and the propagation of the fatigue crack.

1. Turbine blades No.41 and 47 of PT1 were fractured due to fatigue caused by hidden material defect. Probably the failure process was started by the fracture of blade No.47 because it had a longer fatigue crack.

**TSB recommends to Transport Canada to consider the need to early withdraw from service the PT1 rotor blades manufactured before the introduction of NDT improvement or, alternatively, to urgently introduce a one shot X-Ray inspection on all those blades having accumulated a number of cycles beyond a limit to be established (e.g. 2000), specifically focused on the pocket area to exclude the presence of a fatigue crack.**

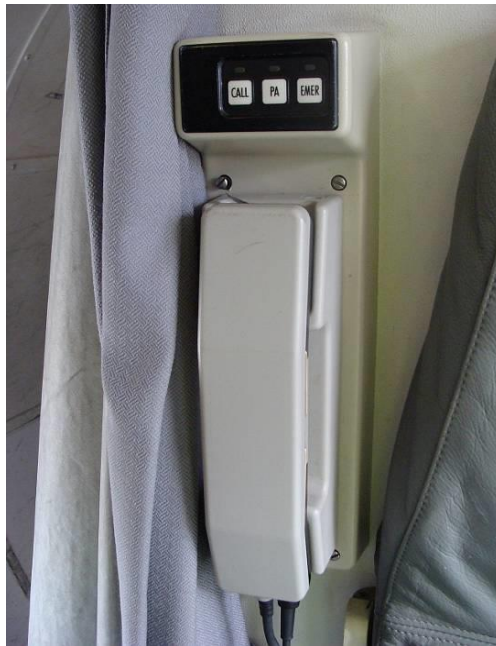
Fig. 17: The rearward PA station

During the emergency landing the Chief Flight Attendant (Purser) initiated an emergency call to the cockpit from the rearward PA station (see Fig. 17) by lifting the handset and pressing the EMER button. When pushed, the EMER button blocks the other buttons of the station including the PA button. The blockage is released when the call is answered or cancelled from the cockpit, or the handset of the station is replaced to the cradle.

**TSB recommends to EASA to consider a modification of the Passenger Address system on ATR aircraft and all other aircraft equipped with similar passenger address systems that it allows release of „EMER” blocking with the PA button (situated next to the „EMER” button) or in other suitable way.**

**As a temporary measure until the above recommendation is implemented, TSB recommends to EASA to apply changes in the Cabin Crew Operating Manuals of the affected aircraft types in order to direct the attention of cabin crew members with more emphasis to the possibility of PA blocking release by replacing the handset back to its holder.**

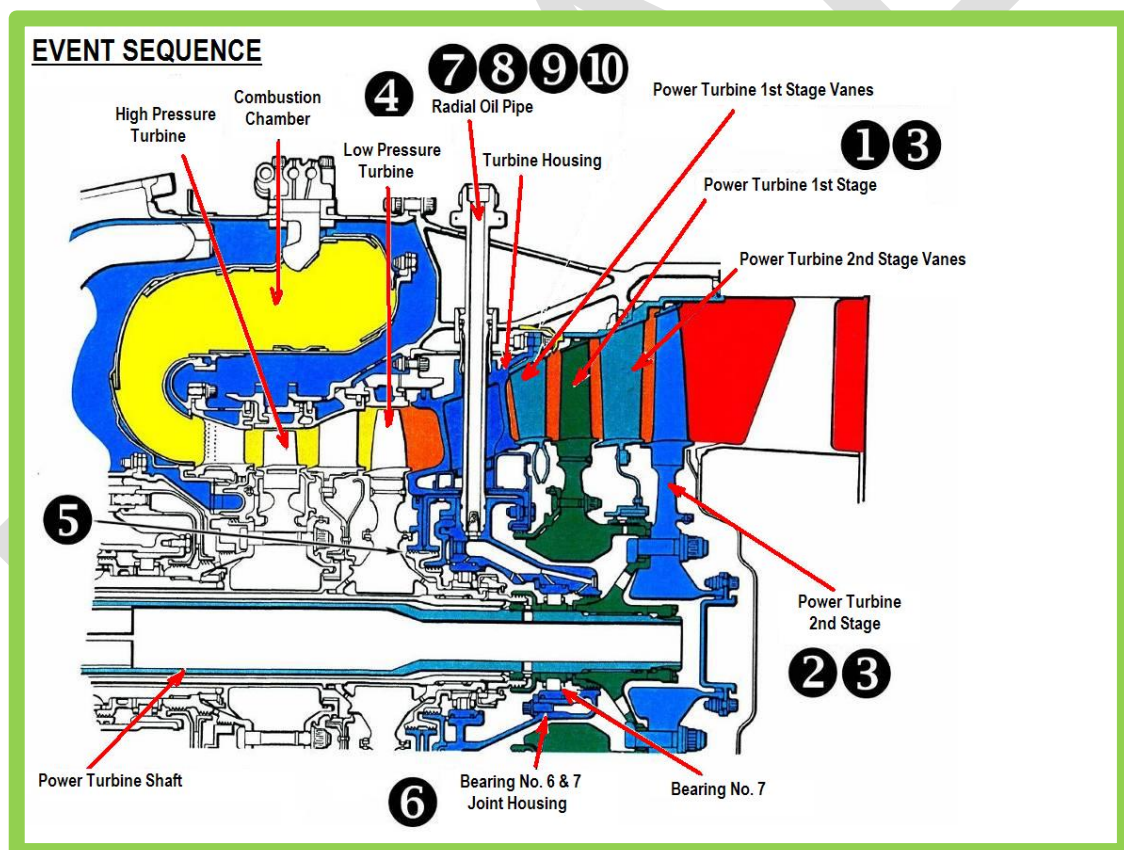
Fig. 20: Engine damage sequence (illustration for description in 2.1.2)

- 1) Blade 47 (and possibly blade 41) in PT1 of RH engine break off. The broken blades damage the other blades of the PT1.
- 2) Consequential damage to PT2 due to debris moving downstream.
- 3) The whole Power Turbine becomes imbalanced.
- 4) Consequential imbalance of the low pressure turbine rotor.
- 5) The low pressure turbine rotor comes in contact with the housing of bearings 6-7 near the labyrinth seal area.
- 6) The shaft rotates the bearing housing along the axis of rotation.
- 7) Due to the above rotation the bearing housing radial oil pipes gets sheared.
- 8) Due to the broken supply oil pipe the engine oil pressure drops.
- 9) The engine oil spills into the engine nacelle.
- 10) The spilled oil comes in contact with hot engine parts and catches fire.
