TRANSPORTATION SAFETY  
BUREAU

**Subject: Final Report** on serious incident, **YR-ATG, 17 June 2011, BUD, Hungary**  
(file number: **2011-120-4P**)

**FINAL REPORT**  
**2011-120-4P**  
**SERIOUS INCIDENT**  
**BUDAPEST**  
**17 JUNE 2011**  
**ATR42-500**  
**YR-ATG**

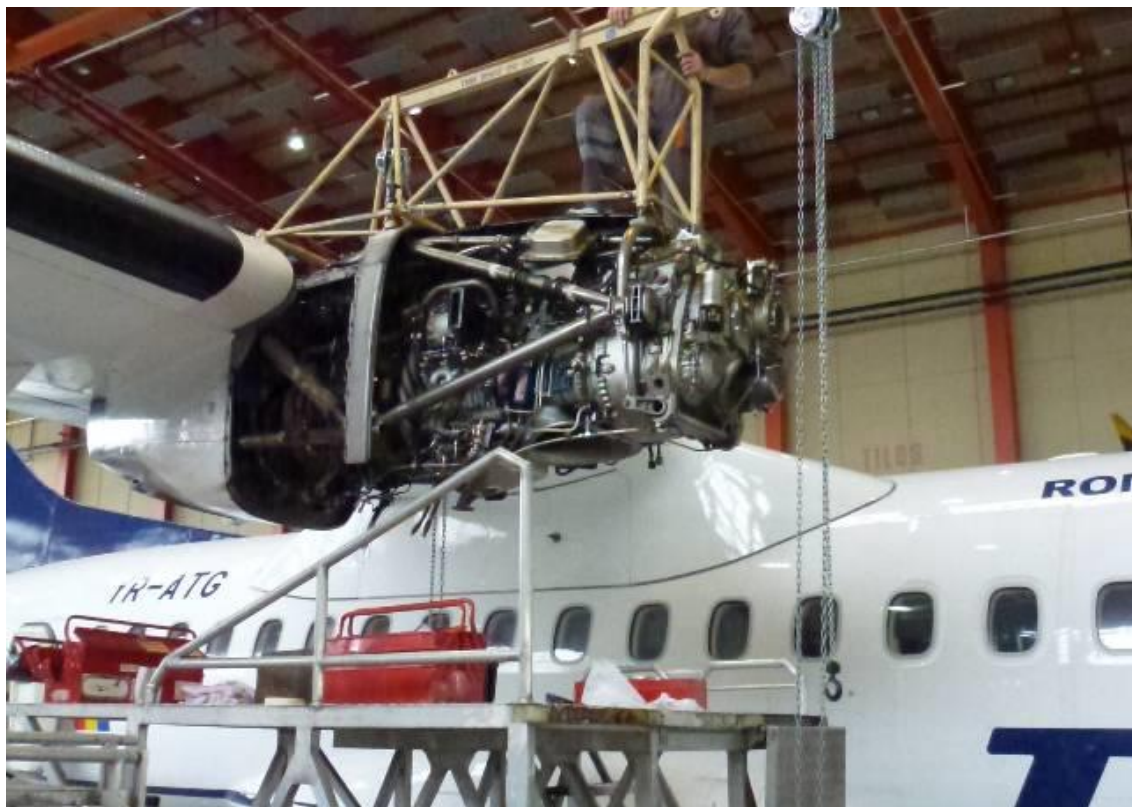
**Fig. 1: Engine removal from the aircraft**

defective engine from the aircraft under TSB supervision. TSB took the engine under custody and arranged its transportation and shop inspection at the Avio Company, Pomigliano d'Arco, near Naples, Italy. There the engine (Fig. 1) was disassembled and inspected under TSB supervision and all interested parties present. The PT1 rotor assembly was removed and sent to Pratt&Whitney Canada for further laboratory inspection under TSB Canada supervision. The inspection determined that the turbine blade fracture was caused by material defect and subsequent fatigue crack.

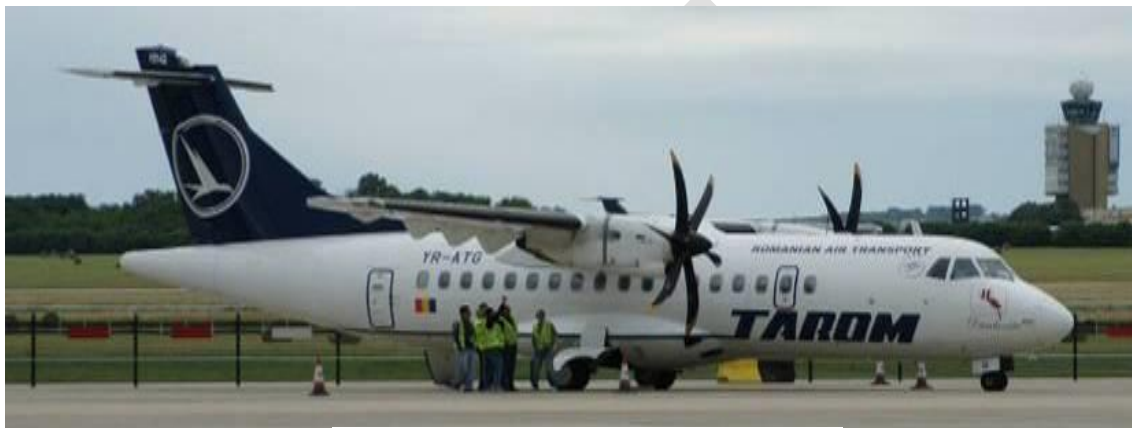
**Fig. 2: The aircraft on the apron**

The ATR42-500 aircraft (registration YR-ATG, operated by TAROM) took off from runway 31L of Budapest Liszt Ferenc International Airport for Bucharest (as flight ROT234) at 17:21 UTC on 17 June 2011. The flight crew noticed the failure, flameout and fire of RH engine 11 seconds after rotation. The flight crew acted in accordance with the emergency checklist and declared MAYDAY while making a turn with the intention to land. The passengers panicked when they noticed the smoke in the cabin and the flaming engine through the window. The pilots received clearance for the tower and landed on runway 13L, 3 minutes after takeoff. The engine fire was put off in flight. The aircraft exited the runway and stopped on a taxiway where the captain ordered emergency evacuation of the aircraft. One passenger had medical problems due to the emergency situation and required medical assistance. The aircraft was checked by the fire brigade and then towed to the apron (Fig. 2).

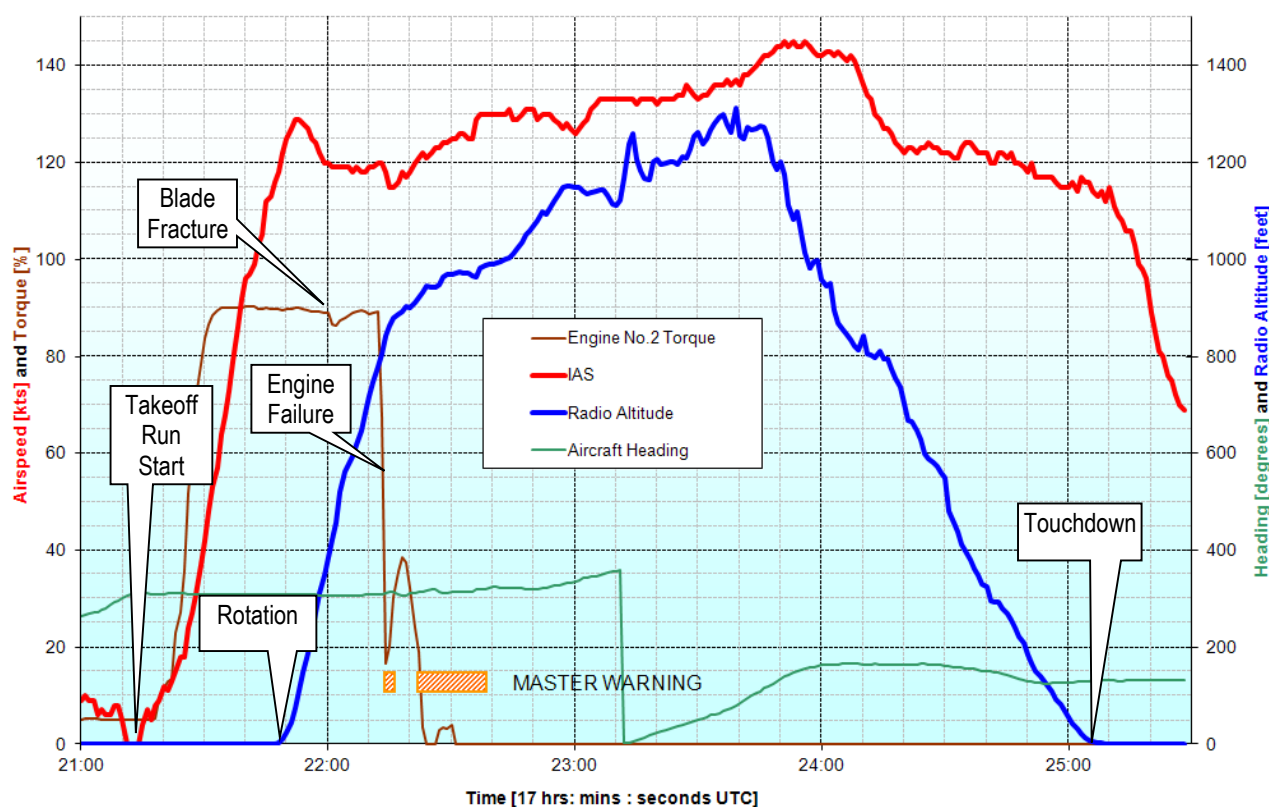
**Fig. 7: Main parameters shown for the full duration of the flight**

The occurrence flight parameters were downloaded from the FDR and analysed. Fig. 7 shows a selected set of parameters for the duration of the flight. It can be determined that the first sign that something was wrong in engine No.2 was a momentary drop of torque, 42 seconds after the start of takeoff run and 11 seconds after rotation. Another 12 seconds later turbine RPM, propeller RPM and torque went to steep fall. Torque dropped to zero in 2 seconds while the propeller stopped in 19 seconds. The gas generator section of the engine stopped another 10 seconds later. The low oil pressure warning came in for 2 seconds when the torque first dropped, followed by the engine fire warning 6 seconds later. It is remarkable how quickly the flight crew reacted to the low oil pressure warning: they started to reduce thrust on engine No.2 two seconds after the warning (see Fig. 8, black line, PLA\_2).

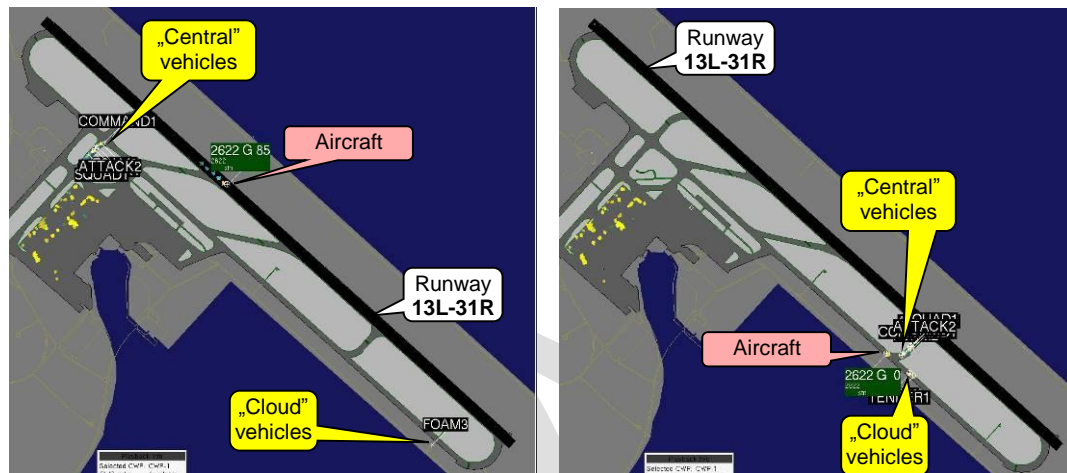
**Fig. 9: Position of the RKI vehicles at the time of landing and stopping as shown on Advanced Surface Movement Guidance & Control System (A-SMGCC) screen**

The aircraft taxied to the intersection of taxiways X and A8 (see Fig. 9) where the captain ordered emergency evacuation. There was no physical injury. Only one passenger - who was affected by the stress of the situation - needed medical assistance.

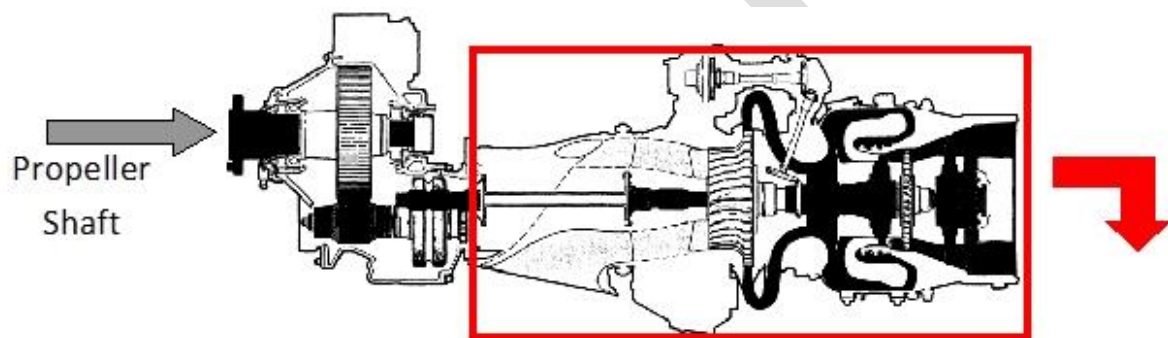
Fig. 18: PW127E engine schematics

Based on the findings of the laboratory inspection (see 1.16.2) two turbine blades of the 1st stage (blades No.41 and No.47) fractured due to fatigue. The expert analysis gives a greater probability to a scenario where blade No.47 broke off first, based on the fact that the fatigue crack length in blade No.47 was more than twice the length of the crack in blade No.41. The cracks propagated from hidden material defects.
